CASE REPORT

# Dental root elevator embedded into a subgingival caries: a case report

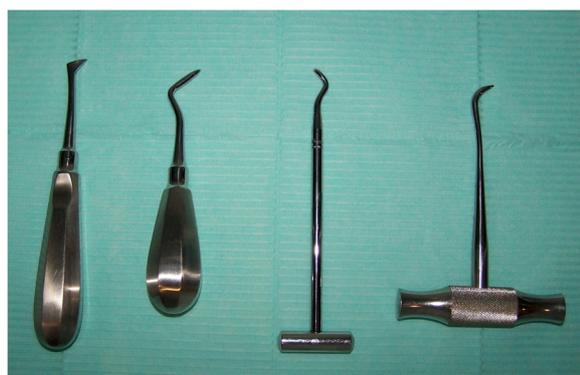
A tooth elevator is an instrument used in minor oral surgical procedures to luxate the tooth or fractured root from its socket. There is a vast range of elevator designs, including right and left sides for several types (Figure 1). Alveolar bone fracture and fracture/luxation of the adjacent tooth are two common problems associated with their use.

**Figure 1** Luxating dental elevators with curved bladed tips to facilitate root extraction.

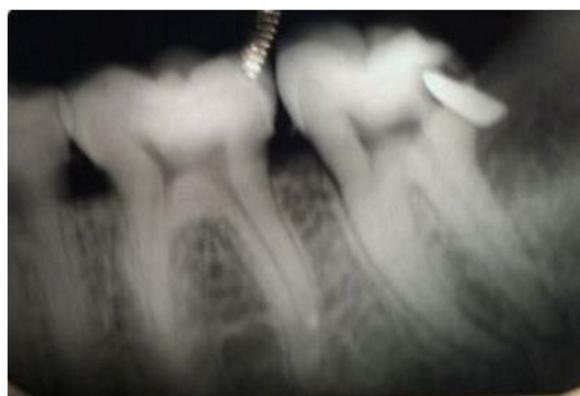
findings. The patient explained that his mandibular left third molar had been extracted six months previously and that the surgery had been quite laborious and lengthy. Although the healing process had been satisfactory, considerable pain had recently begun in this area. The dental X-ray showed an image consistent with a piece of metal embedded in a subgingival distal caries at the mandibular left second molar (37), which was probably related to a previous tooth impaction process of the mandibular left third molar (38). Two periapical lesions detected at the mandibular left second molar roots might have justified his acute tooth ache due to acute exacerbation (Figure 2).

Initially, the differential diagnosis of this radiographic finding was that of a possibly loosened or released piece of amalgam. Nevertheless, the patient had never previously undergone any dental fillings. After repeating the X-ray twice in order to rule out a possible image artefact, it was concluded that during the third molar extraction a curved

**Figure 2** Periapical radiographic image: Notice the curved blade elevator tip broken and embedded in a subgingival caries cavity of the mandibular left second molar (37). Observe two radiolucent apical lesions in the affected molar (37) and a slight radiopacity located on the distal part of the first molar crown (36), which was a consequence of the Kocher clamp used during a manual developing process.

blade elevator tip had fractured and impacted into the subgingival caries cavity. As the patient had only been referred for a dental X-ray he was given a written note explaining the finding. His dentist was informed about the need to perform an occlusal access cavity in order to initiate a root canal treatment and remove the foreign body from the second molar (37).
